INDIAN FIELDS BRANCH, CUMBERLAND COUNTY

# EAST LAKE DAM

## PHASE I INSPECTION REPORT NATIONAL DAM SAFETY PROGRAM

MARCH 1978

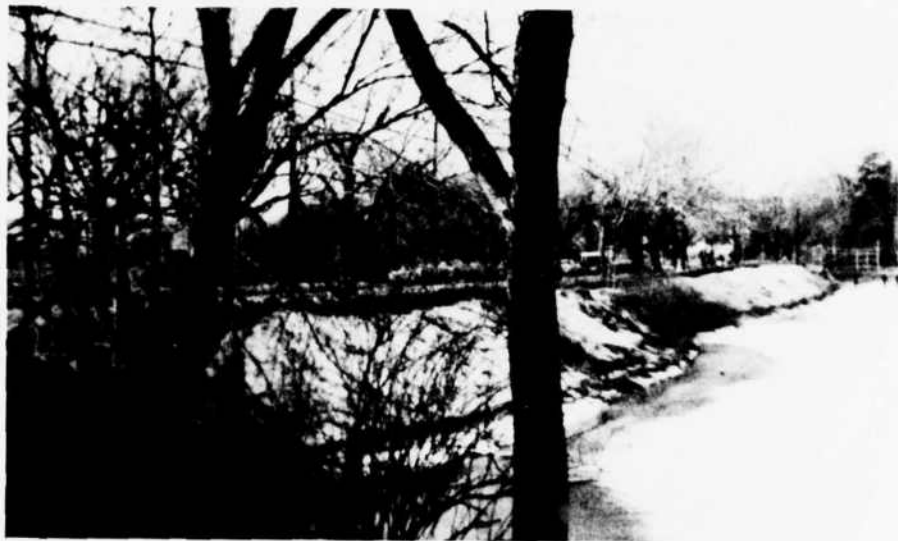
UPSTREAM FACE OF EMBANKMENT LOOKING WEST

At several locations, bank sloughing has created vertical scarps of 2-3 feet on the upstream face. Settlement across the top of dam was noted at several locations with one settlement area of about 120 sq. feet with a maximum settlement of 2.5 feet.

The upstream face should be repaired with a suitable material and provided with an appropriate riprap surface.

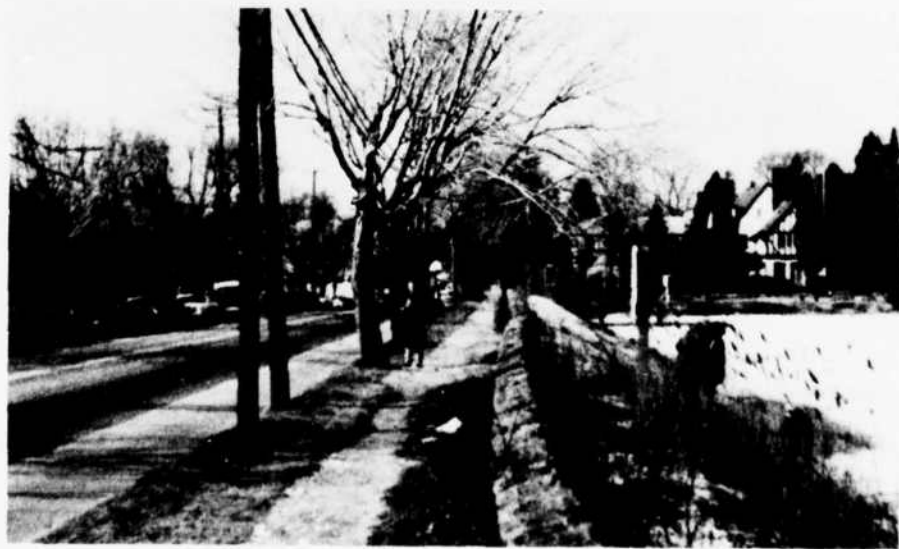
TOP OF DAM LOOKING WEST—UPSTREAM SIDE

a. Dam. The dam is an earth embankment with a stone wall on the upstream side of the crest. The stone wall is noticeably settled and tilted. The upstream slope consists of a loose sand fill which shows evidence of erosion and settlement. Vertical depressions of 2 to 3 feet are evident near the water surface. There are no training walls at the outlet structure to protect against the effects of erosion in this area. Erosion to depths of 3 to 4 feet is apparent for a length of 30 feet west and 50 feet east of the outlet structure. Sand has been placed in these areas to protect the embankment.

- c. Within one year from the date of approval of this report, the road surface drainage problem on top of the dam should be rectified, the wall on the upstream side of the roadway repaired and the settled areas atop the dam properly filled.

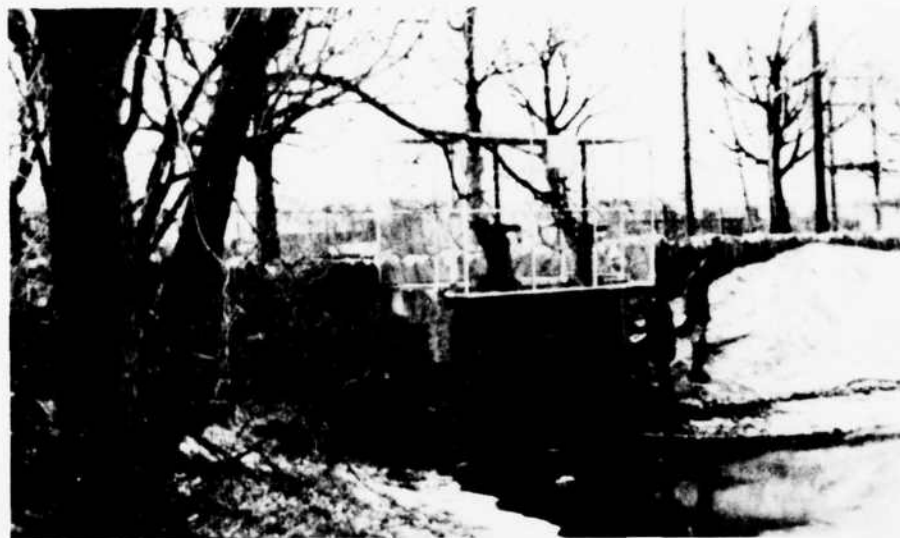
Embankment erosion was noted to depths of 3-4 feet on both sides of the east outlet structure for a length of 30-50 feet.

RESERVOIR OUTLET STRUCTURE AT EAST END  
OF EMBANKMENT

These areas should be replaced with suitable materials and protected by training walls or heavy riprap.

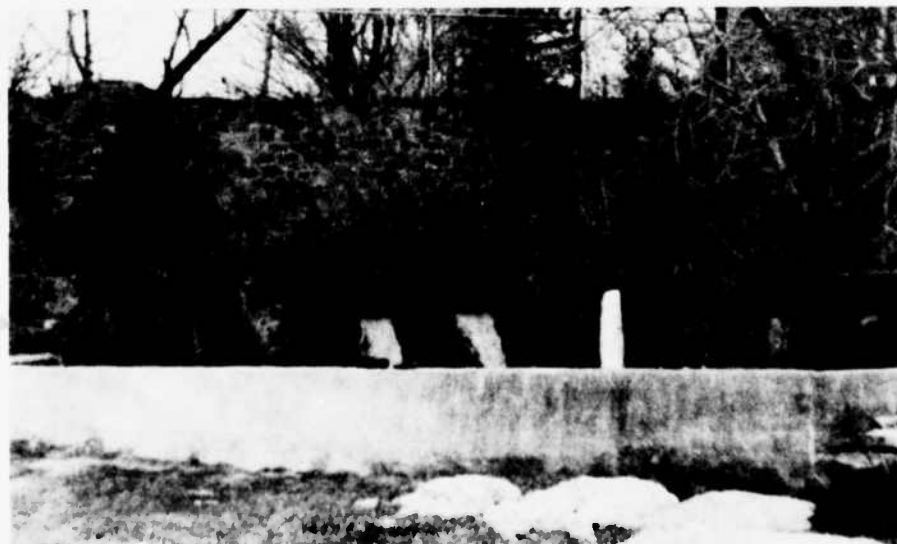
OUTFALL FROM RESERVOIR OUTLET STRUCTURE

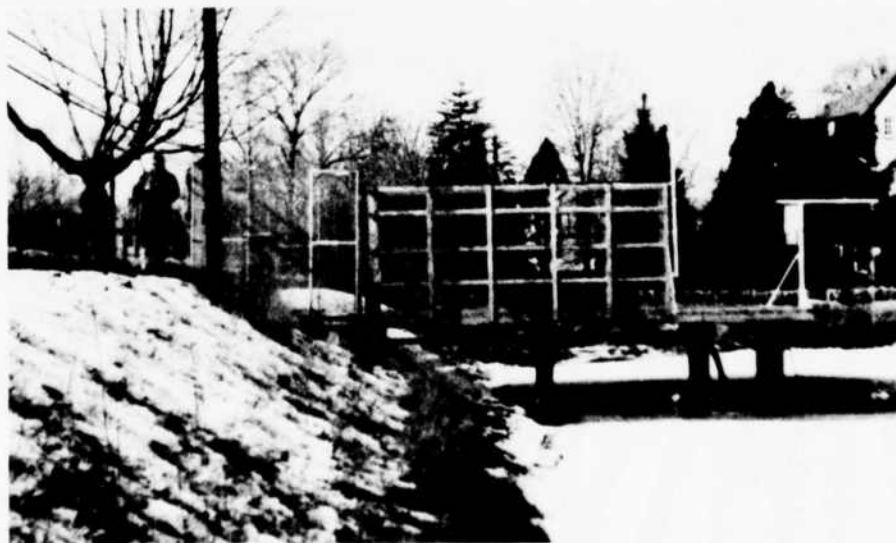
INTAKE STRUCTURE FOR INDUSTRIAL PLANT

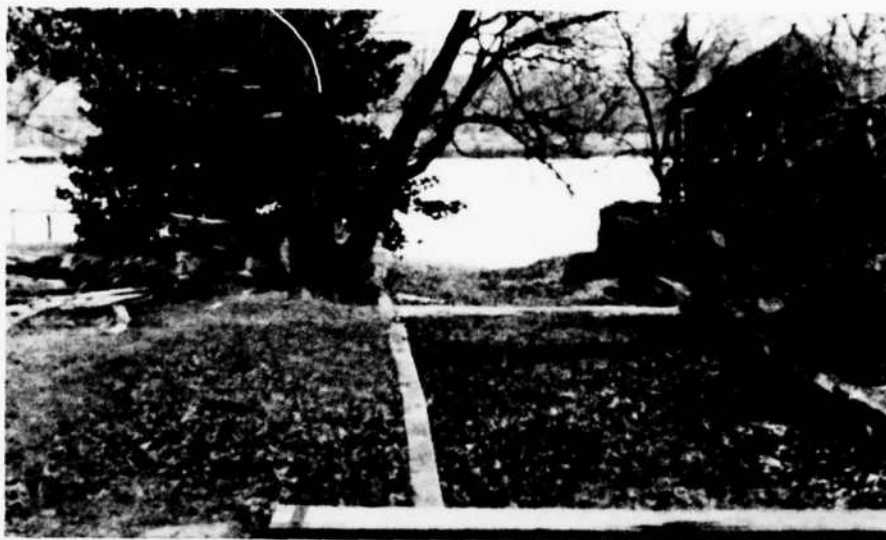
SPILLWAY ON WEST SIDE OF RESERVOIR

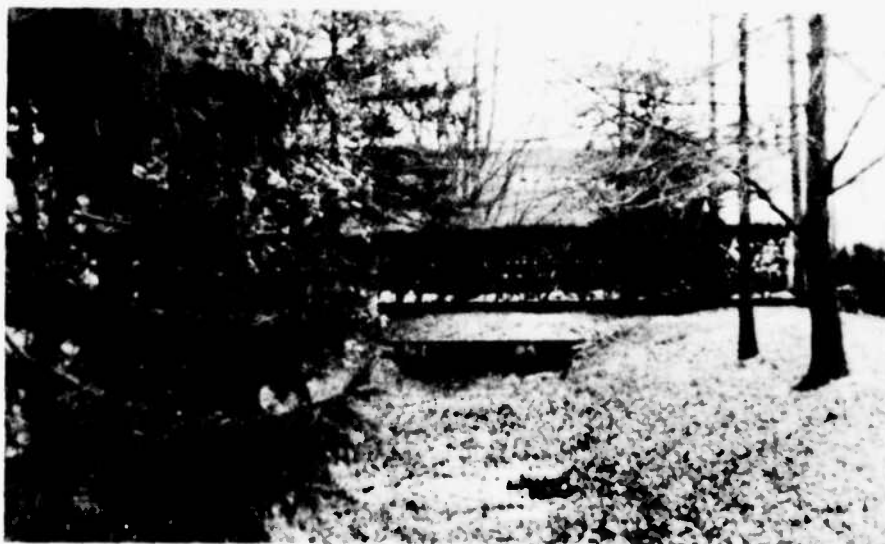
SPILLWAY CHANNEL LOOKING DOWNSTREAM

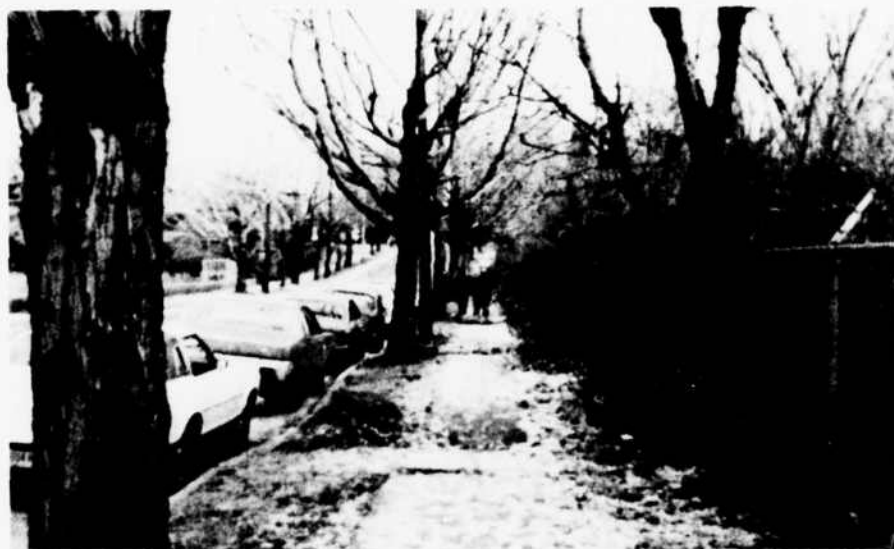
TOP OF DAM LOOKING EAST—DOWNSTREAM SIDE

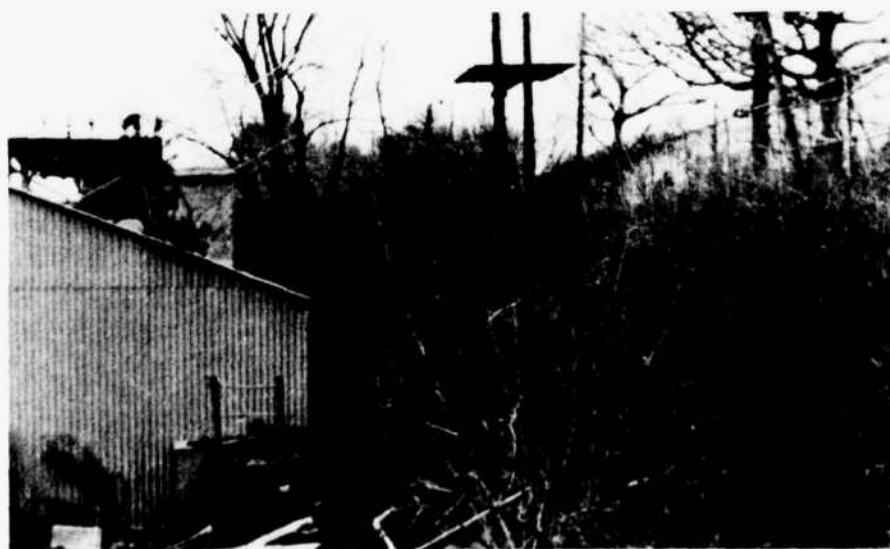
Shrub and tree growth on the downstream slope of the embankment makes it difficult to tell if sloughing of the slope is taking place. No leakage was observed flowing out of the embankment slopes; however, this may be because the drainage is controlled by the foundation subdrain system downstream of the dam. The fact that the top of the dam is over 60 feet wide also has a great influence in controlling the seepage and reduces the danger of slope or piping problems. However, these possibilities still exist.

DOWNSTREAM FACE OF EMBANKMENT LOOKING WEST
